LASH SHIP PRETEST RESULTS OF THE JOINT
LOGISTICS-OVER-THE-SHORE (LOTS) TEST (U) OPERATIONS
RESEARCH INC SILVER SPRING MD H CASEY ET AL. 07 MAR 77

ORI-TR-1121 MDA903-75-C-0016

Rept. No. ORI-TR-1121

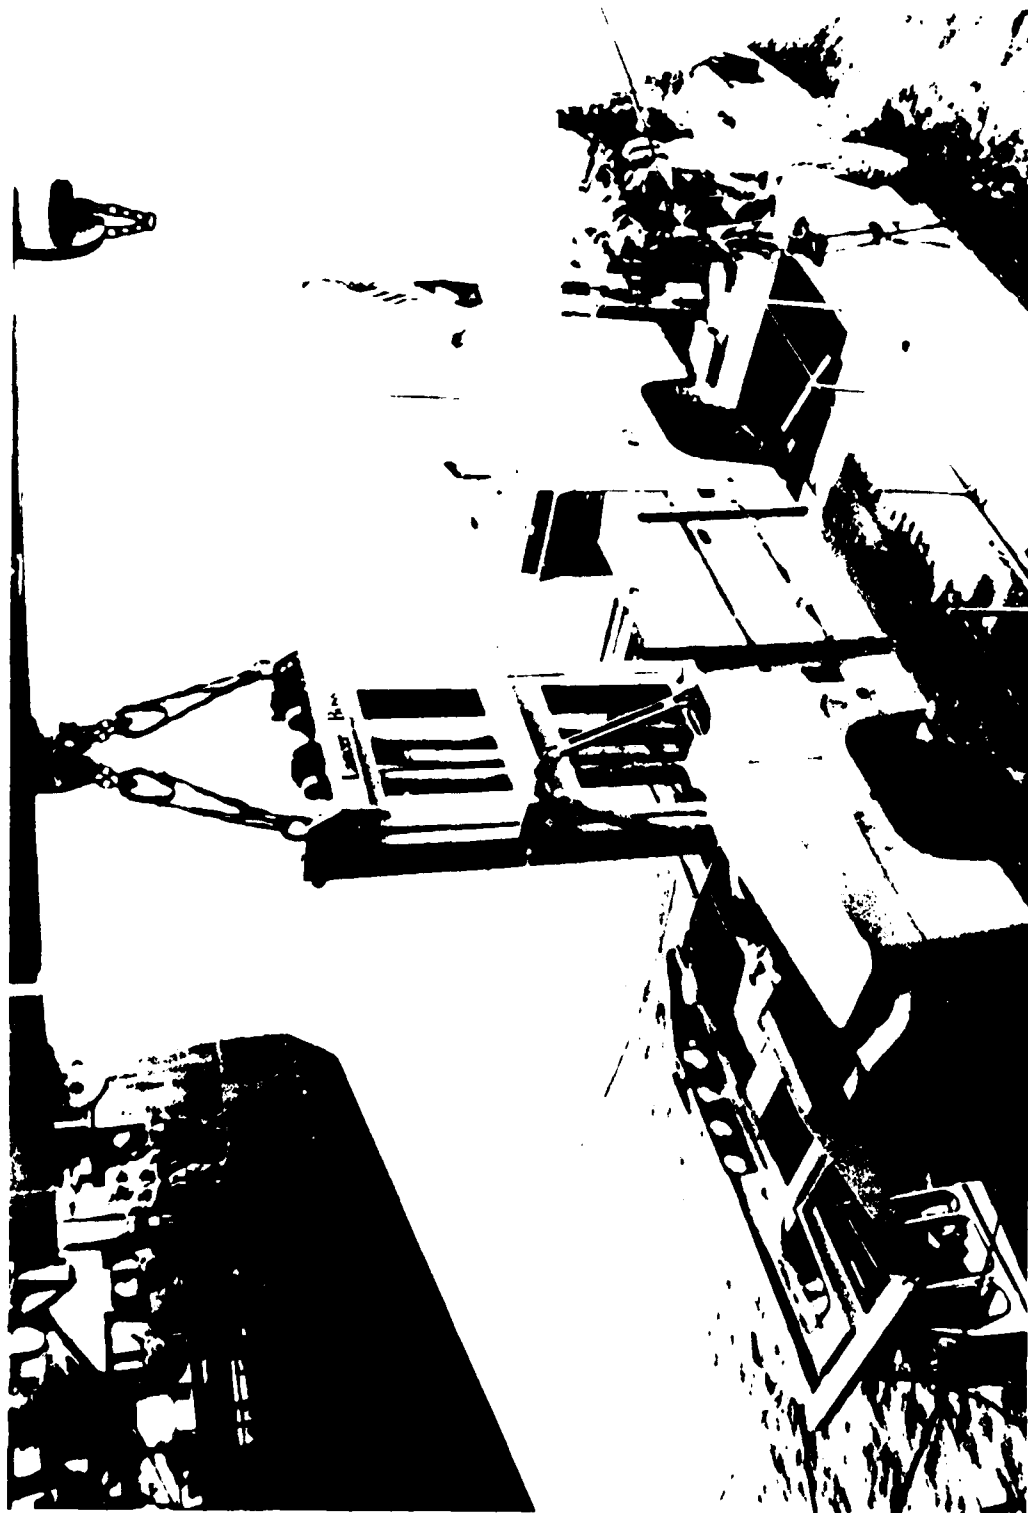
E.32. SIDELOADER IS LOWERED INTO AN LCM. As with the other LOTS wheeled equipment, the side loader was lowered into an LCM. No difficulties were encountered in off-loading the vehicle. The total unloading time, including rigging, was 62 minutes.

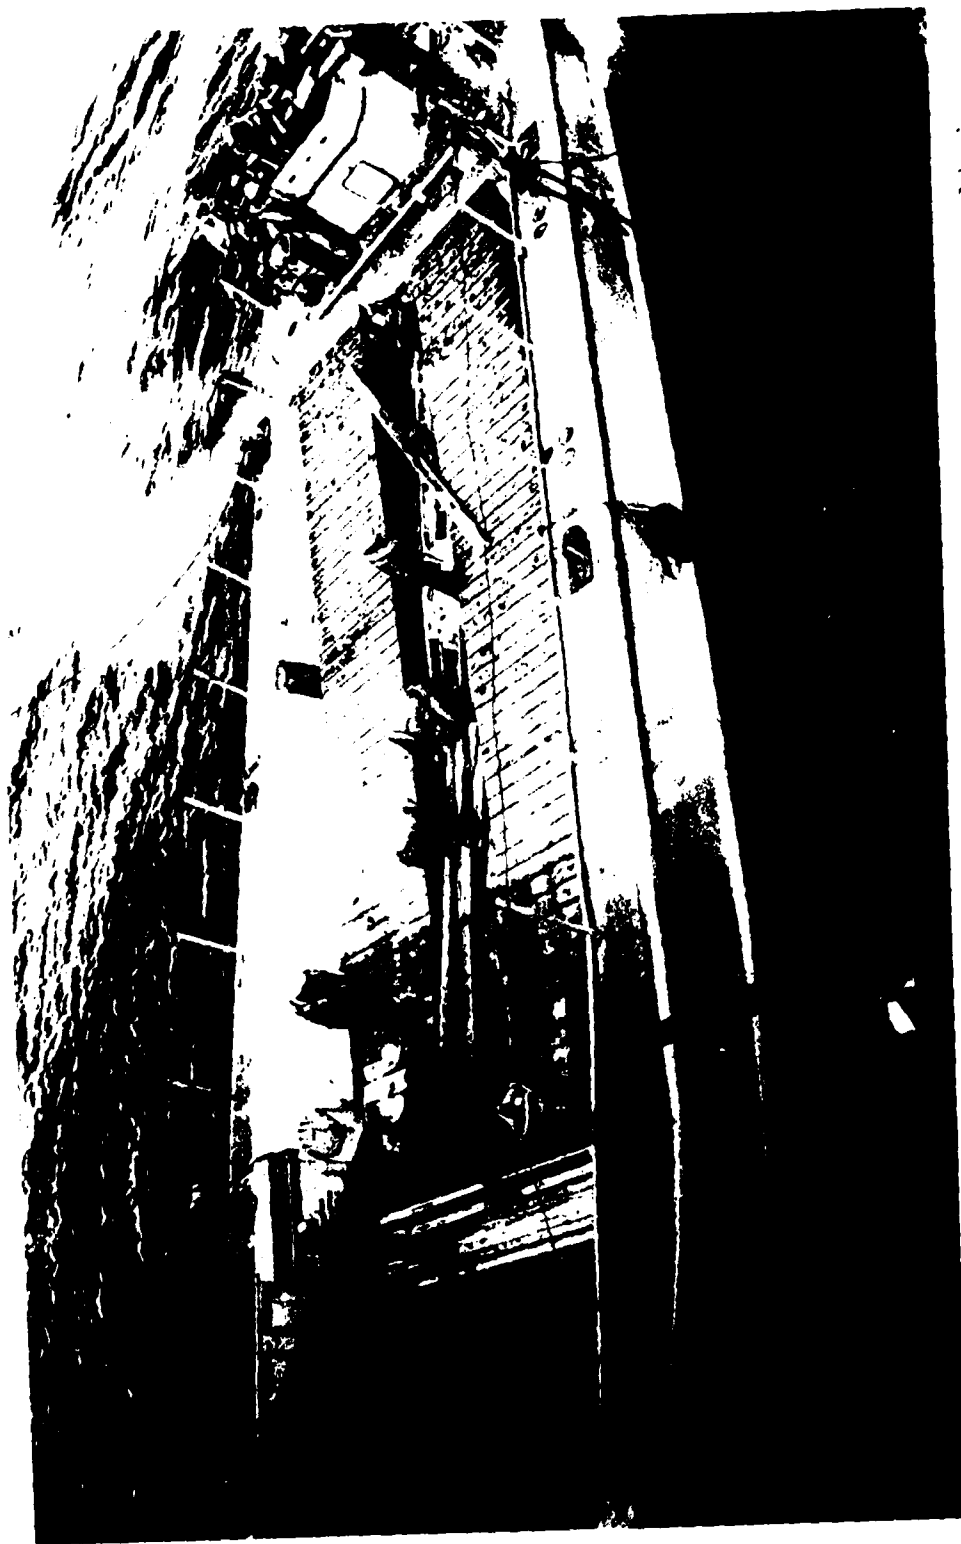
E.34. LCM8 READIED FOR HOISTING. One of the key pretest questions was whether an LCM8 could, in fact, be loaded aboard the LASH. Although the weight was not a factor (an LCM8 weighs 66 short tons, the one above weighed an estimated 76 short tons with the ramps), there had been sling and clearance problems in a 1974 test lift.

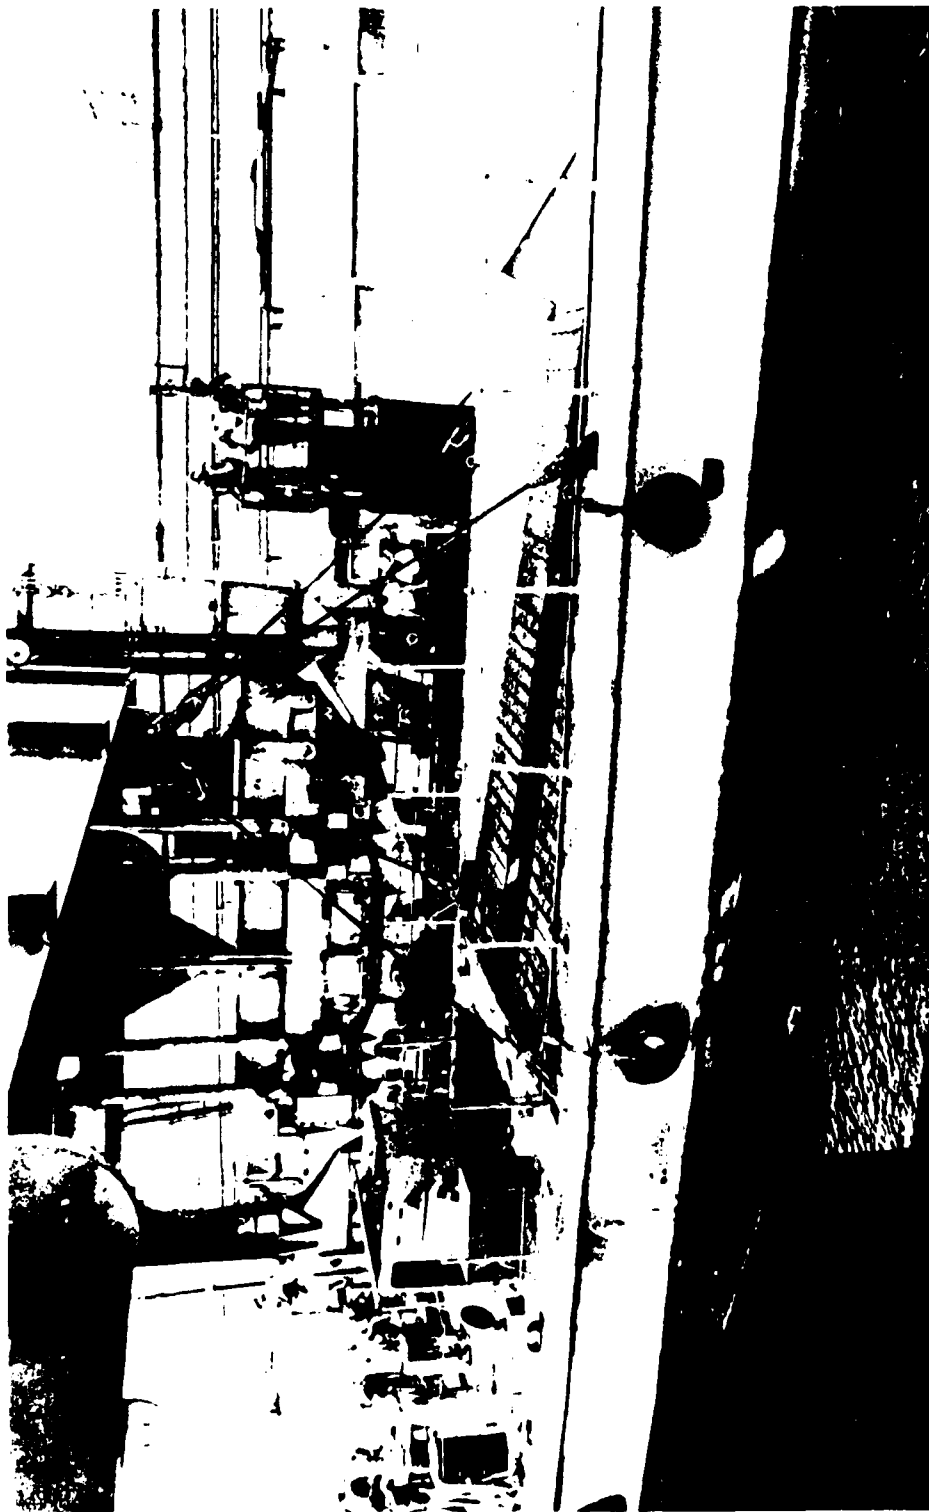
E.35. LCM8 SLING ATTACHMENT. The modified LCM8 sling shown above was used successfully. When the LCM8 was originally tested by Avondale Shipyard in November, 1974, an aluminum LCM8 (with different lifting points) and an unrecorded type of LCM8 lifting sling were used. In addition, the 130-ton shackles used could not be attached to the LCM8 sling directly and an additional pair of shackles had to be used. As a result, the LCM8 in that test lacked approximately two inches to clear the stern of the ship.

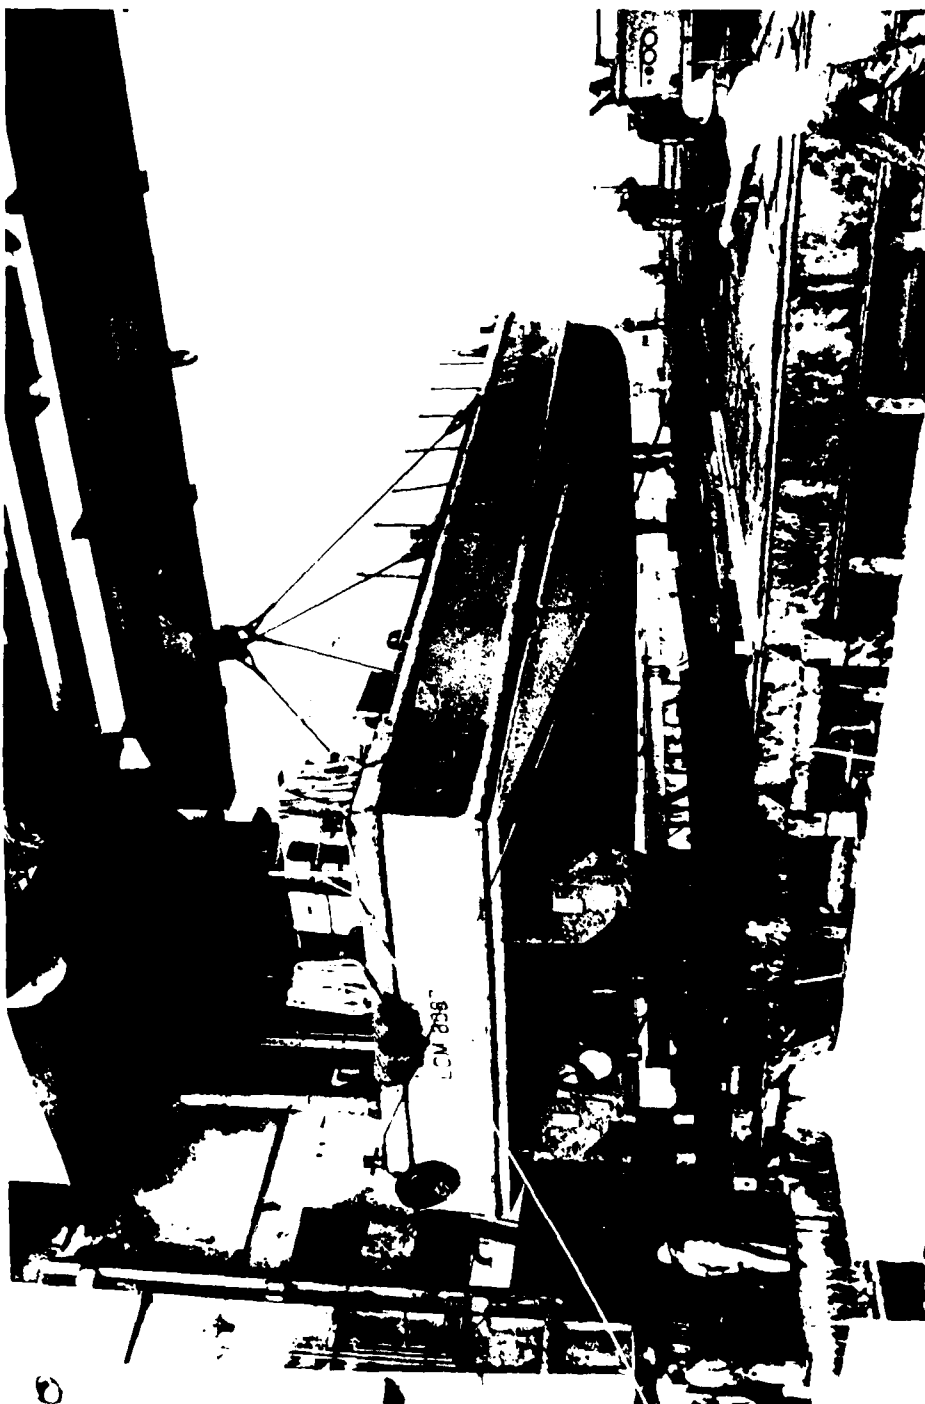
E.37. LCM8 IS LOWERED INTO DUNNAGE. The LCM8 cleared the hatch squares by approximately 4 $\frac{1}{2}$ to 5 feet. The sling used for the LOTS pretest had legs which were shortened by approximately 12 inches to ensure clearance. A normal LCM8 sling would have sufficed. The cycle time, including all rigging, was two hours and 18 minutes for the loading phase and one hour and 16 minutes for the off-loading phase.

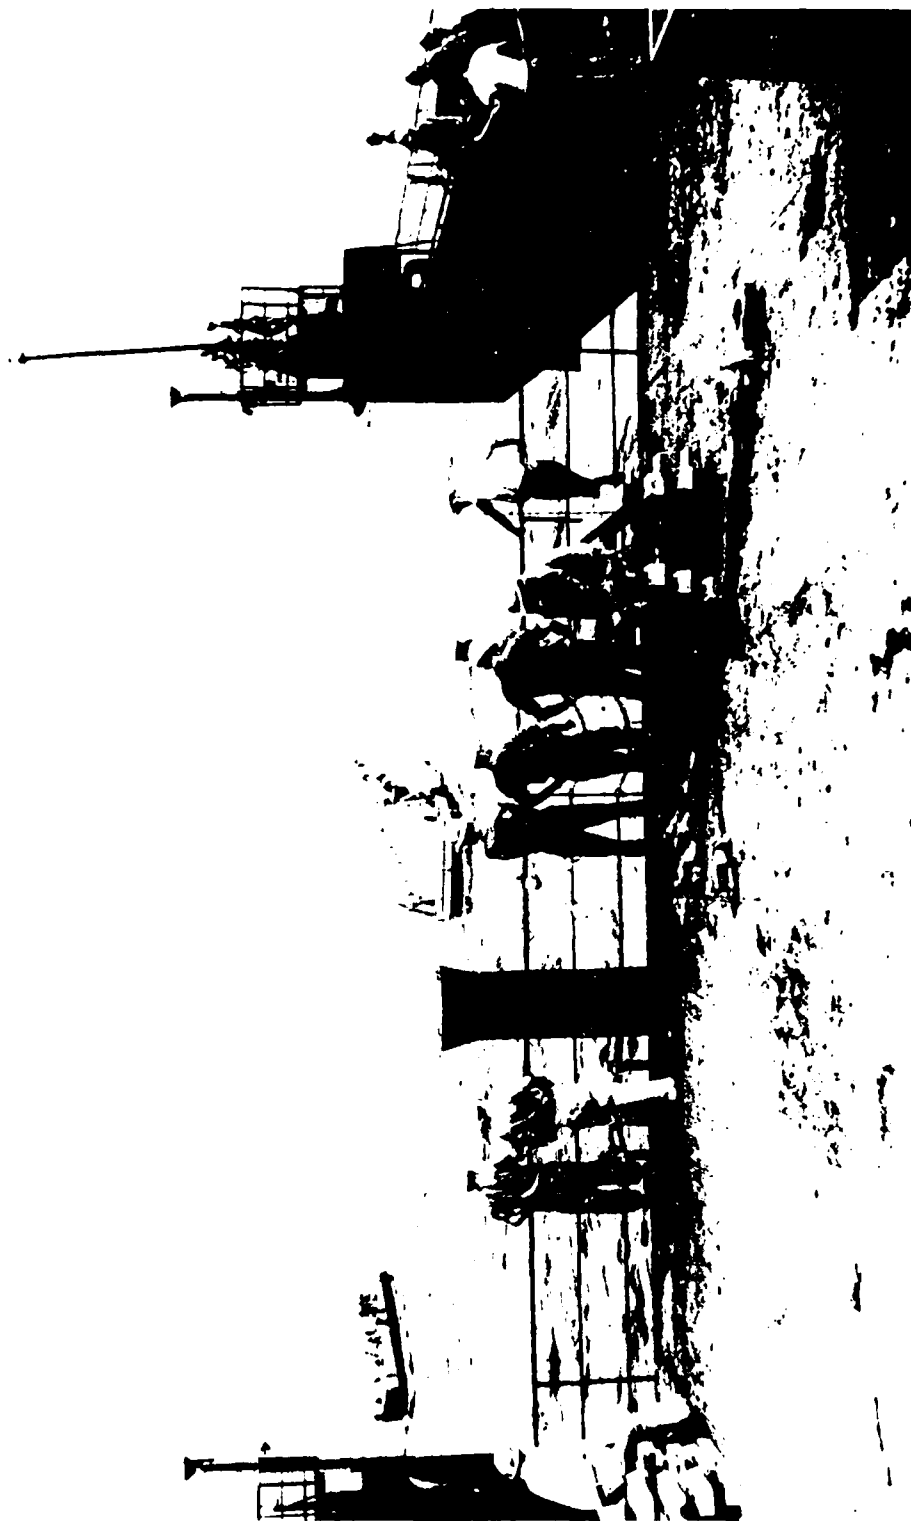
E.40. LCU MAKES APPROACH FOR MOORING. During the off-loading phase while the causeway lifting frame was being attached to the LCM8 lift beams, mooring approaches were made to the LCU from the stern. Above a Navy 1646-class LCU tries a stern gate approach.

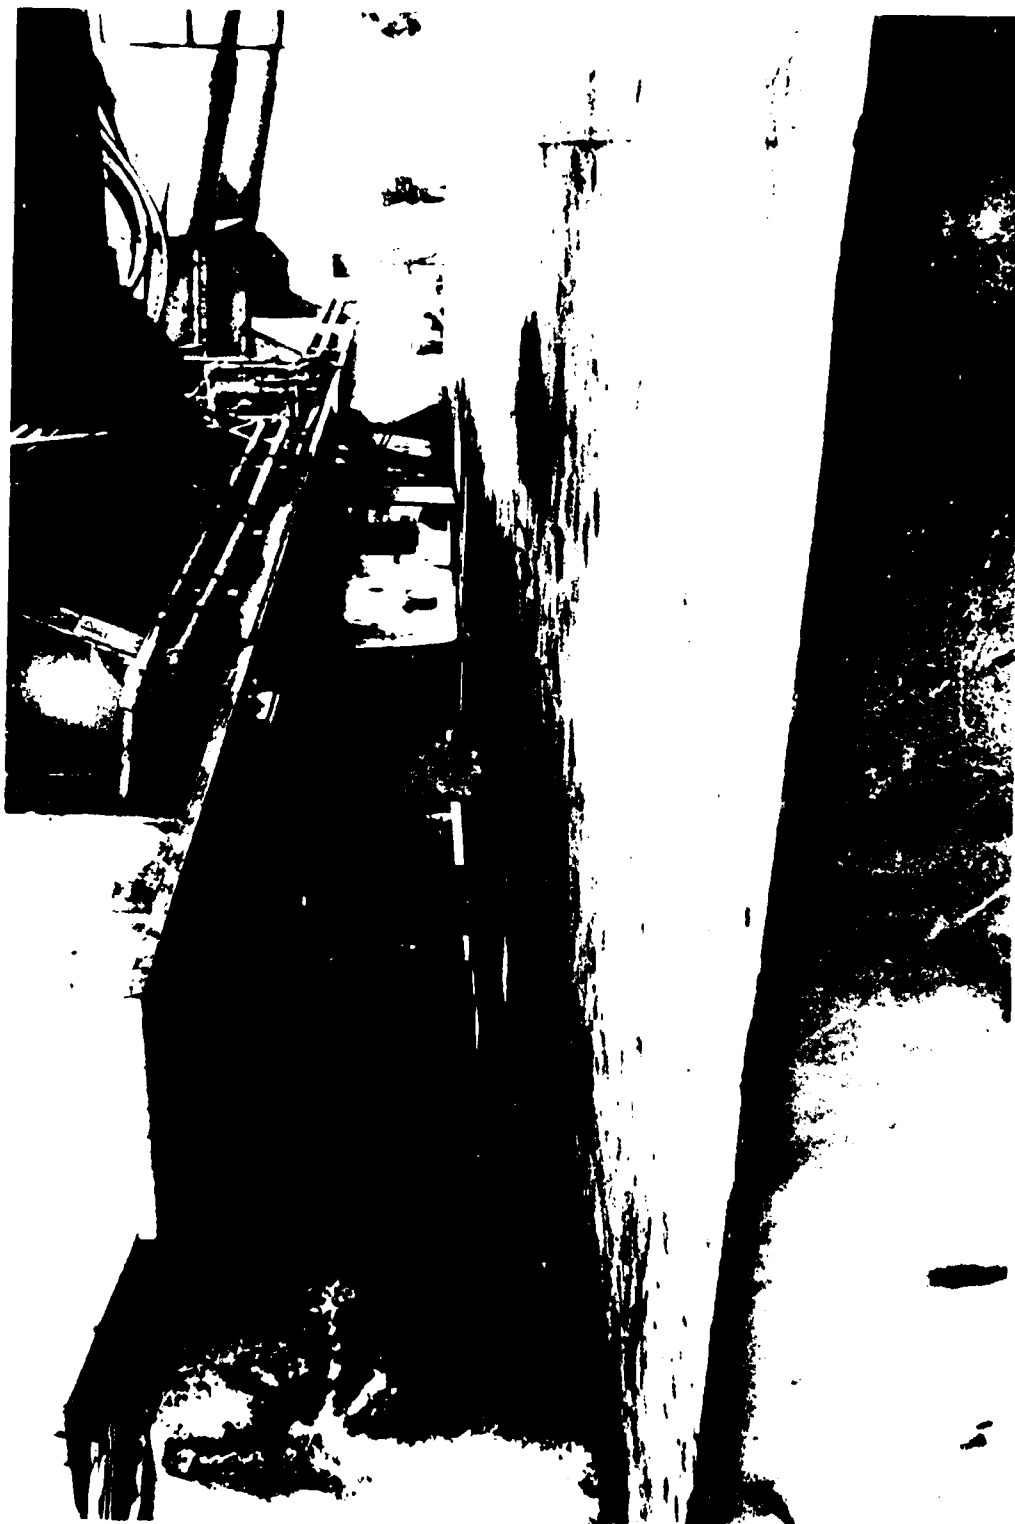
E.43. CRANE ENGAGES HATCH COVER. Once the deck was cleared of test cargo the hatch cover to cell 3C was opened and the last phase of the LASH unloading operations was initiated. The cycle time for removing the hatch cover was 13½ minutes.

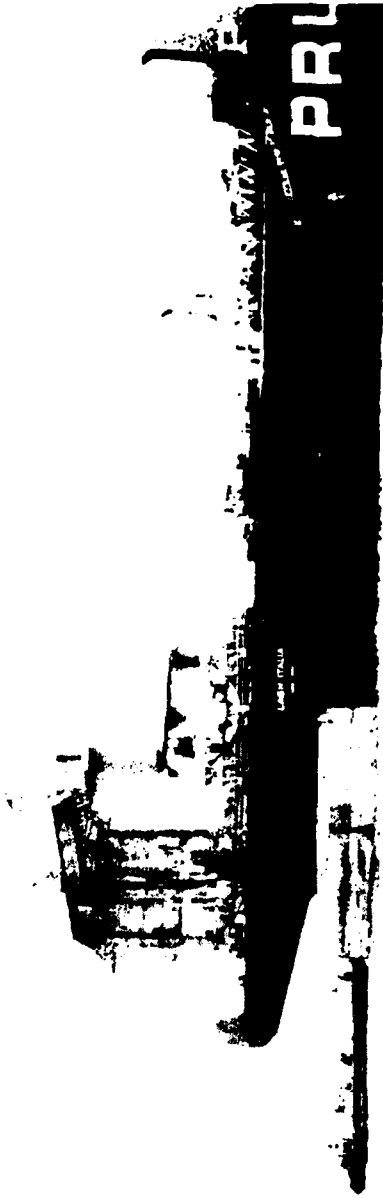
E.47. LCM6 TENDER BOAT CLEARS WELL. Navy LCM6 tender boats/warping tugs were used to clear the LASH barges from the well area. The tender boats had no difficulty towing the barges clear of the well, thereby permitting the barge gantry crane to operate without delays. Subsequently, some difficulty was experienced by one craft when winds and seas became worse.

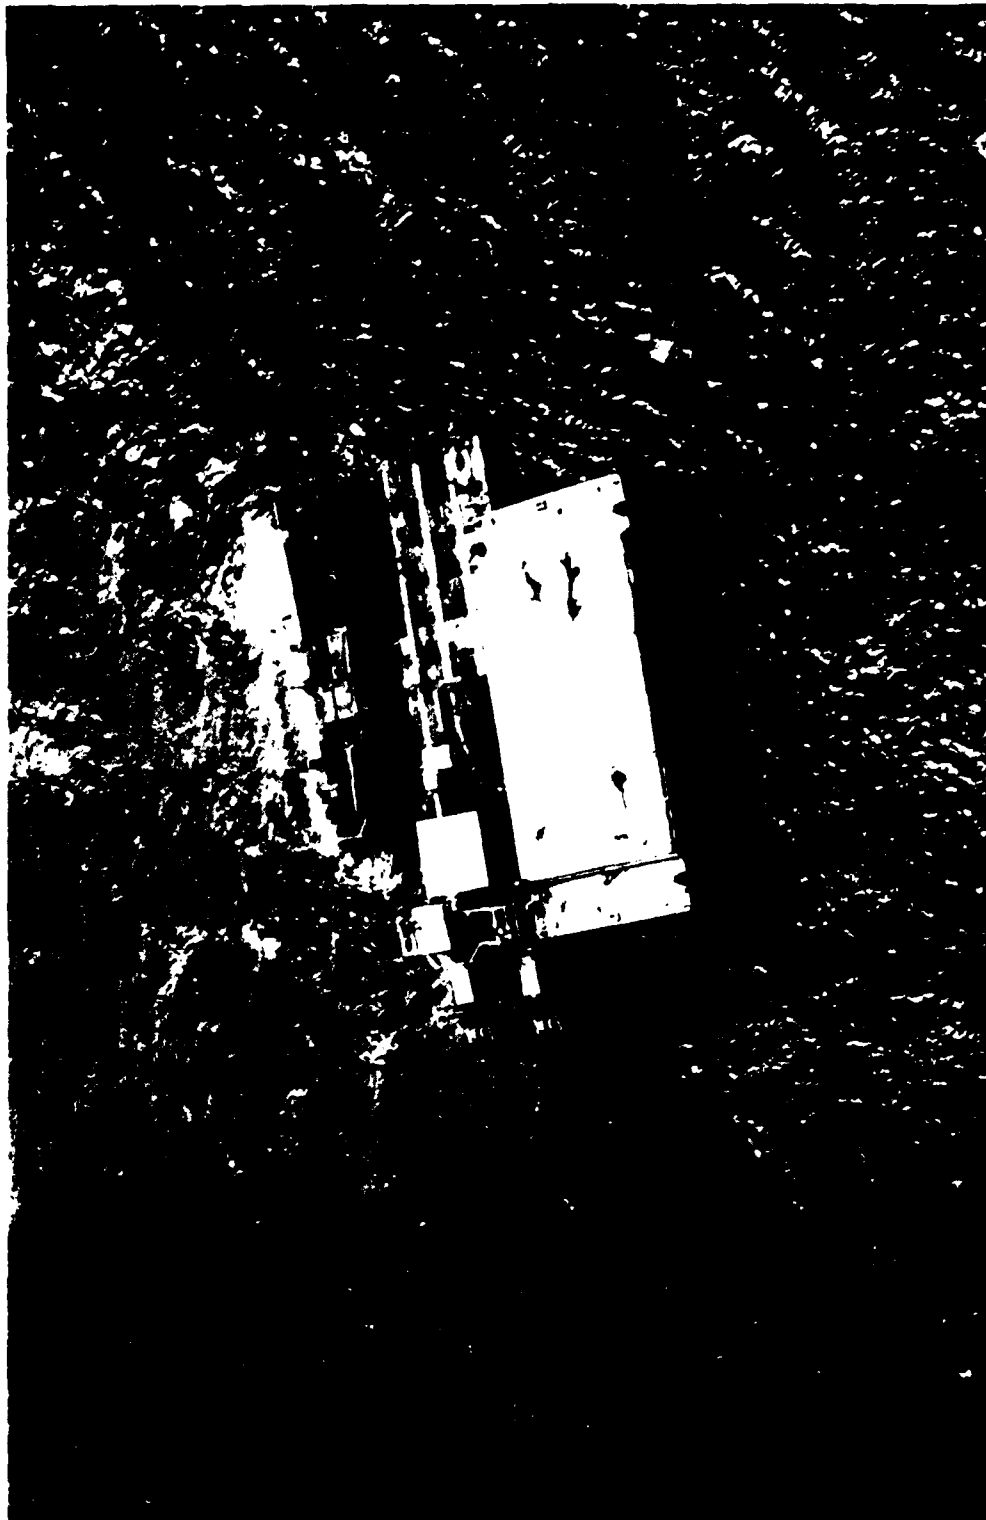
E.48. 3 X 14 CAUSEWAY WARPING TUG TAKES BARGE UNDER TOW. As the seaway conditions worsened an LCM6 tender boat needed assistance from a more powerful 3 x 14 causeway warping tug to moor the barge to a nearby buoy.
